#### **MASSIVE CORROSION**

# Fault-free operations

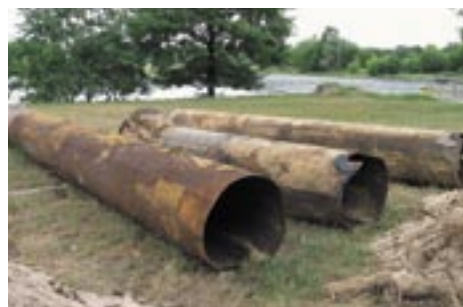
**Massive corrosion was detected in the older steel pipes after only a few years of operation.**
