The great relining of Tervasaari

A tricky sliplining job was carried out at the UPM Tervasaari mill in Valkeakoski, Finland, in June–July 2005. A 710-millimetre polypropylene pipe was inserted into an existing 900-millimetre pipe for its entire 600-metre length.

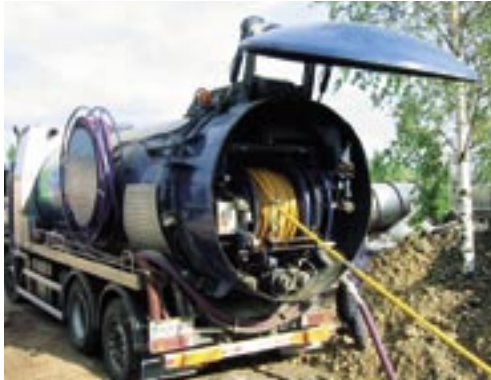
The pipes were pulled into place using a winch truck and a hydraulic ram.

According to Ari Vaarala, Operations Manager at KWH Pipe Finland's rehabilitation department, the first section of liner was about 175 metres, and the longest of the three sections had a length of 250 metres. He adds that the pipes were pulled into place using a winch truck and a hydraulic ram and that the wire in the winch truck was 300 metres long.

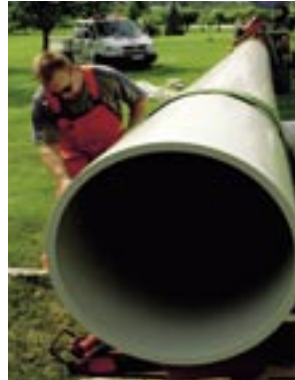
Sami Niemi preparing the relining pipe.

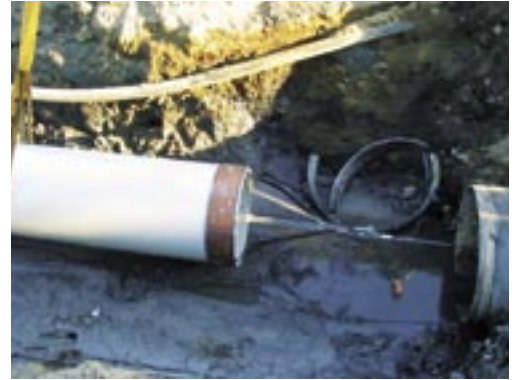
The new pipes were inserted into the old ones in three stages. Each individual pipe had a length of 18 metres.

The relining was carried out in three stages. The individual pipes were 18 metres long and they were supplied by KWH Pipe's Vaasa plant. One transport vehicle could carry nine pipe sections at a time.

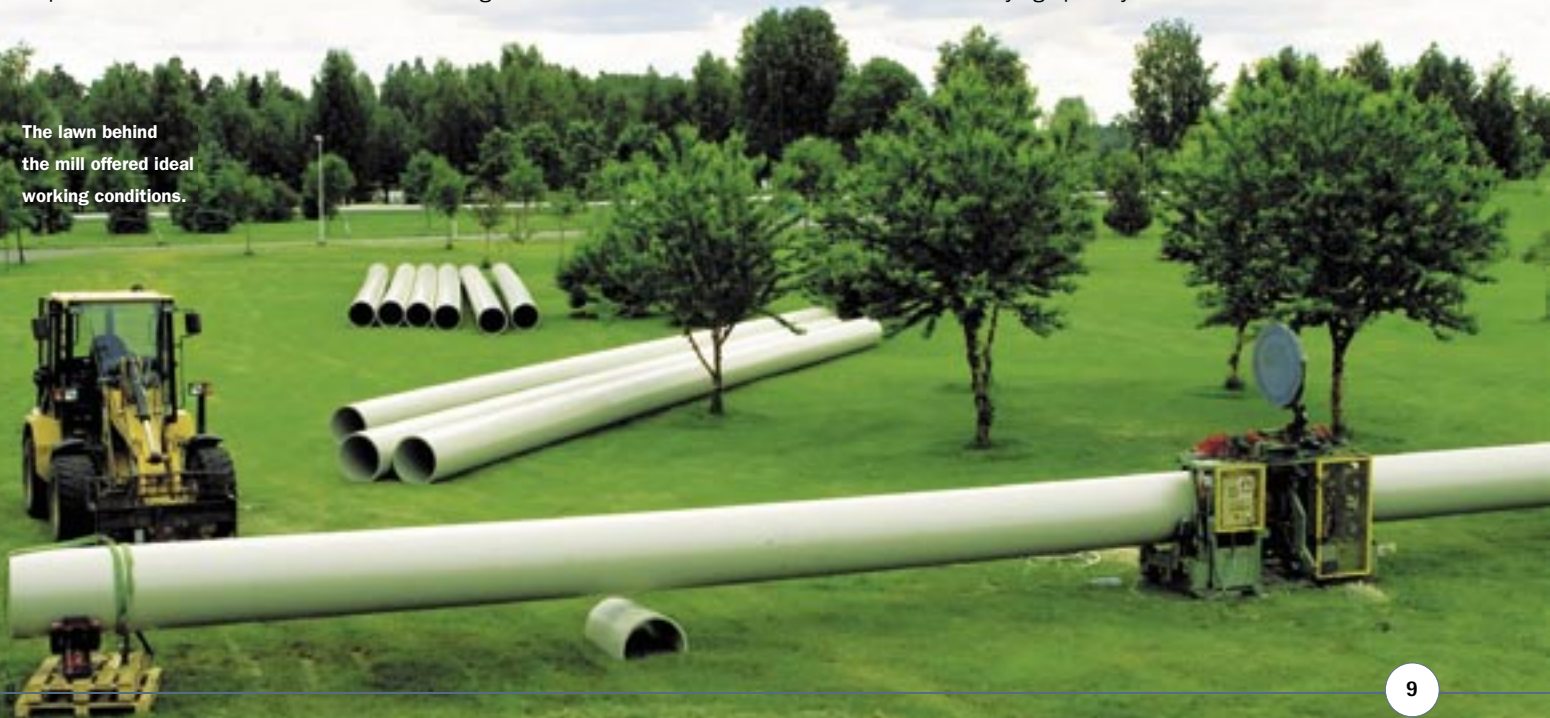
The lawn behind the mill offered ideal working conditions.

Working conditions at Tervasaari were ideal. There was a splendid lawn behind the mill with plenty of working space, and the sunny weather also helped to speed up the project.
