# Relining

## allowed road traffic to flow unhindered

**The sheet metal culvert through the Åvabro causeway was no longer able to withstand the aggressive impact of the Åland archipelago seawater. Building a new culvert would have meant a road closure lasting several days. The problem was solved by inserting a plastic pipe into the existing culvert.**

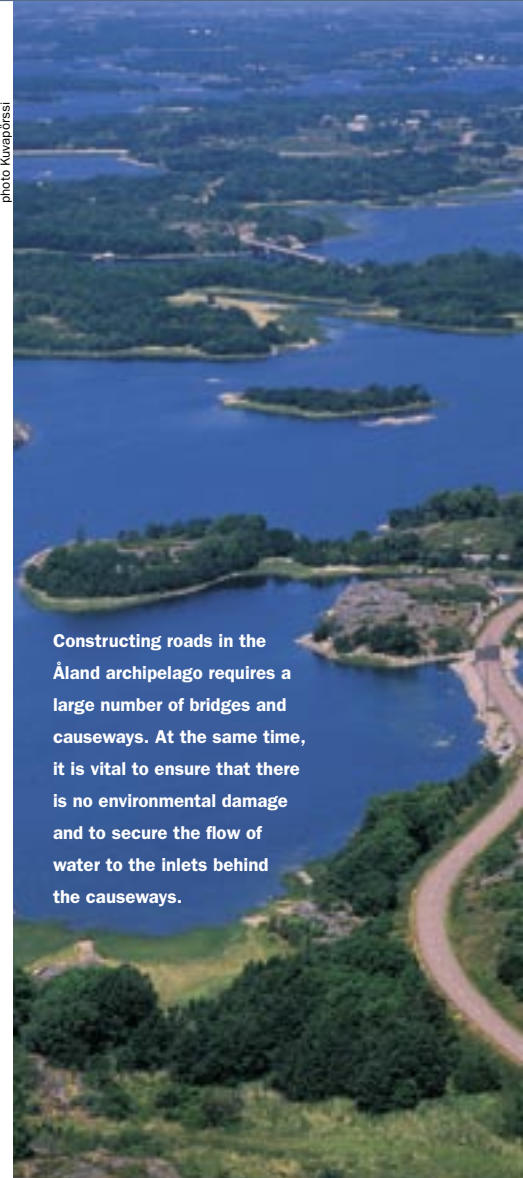
photo: Kivapössi

Constructing roads in the Åland archipelago requires a large number of bridges and causeways. At the same time, it is vital to ensure that there is no environmental damage and to secure the flow of water to the inlets behind the causeways.

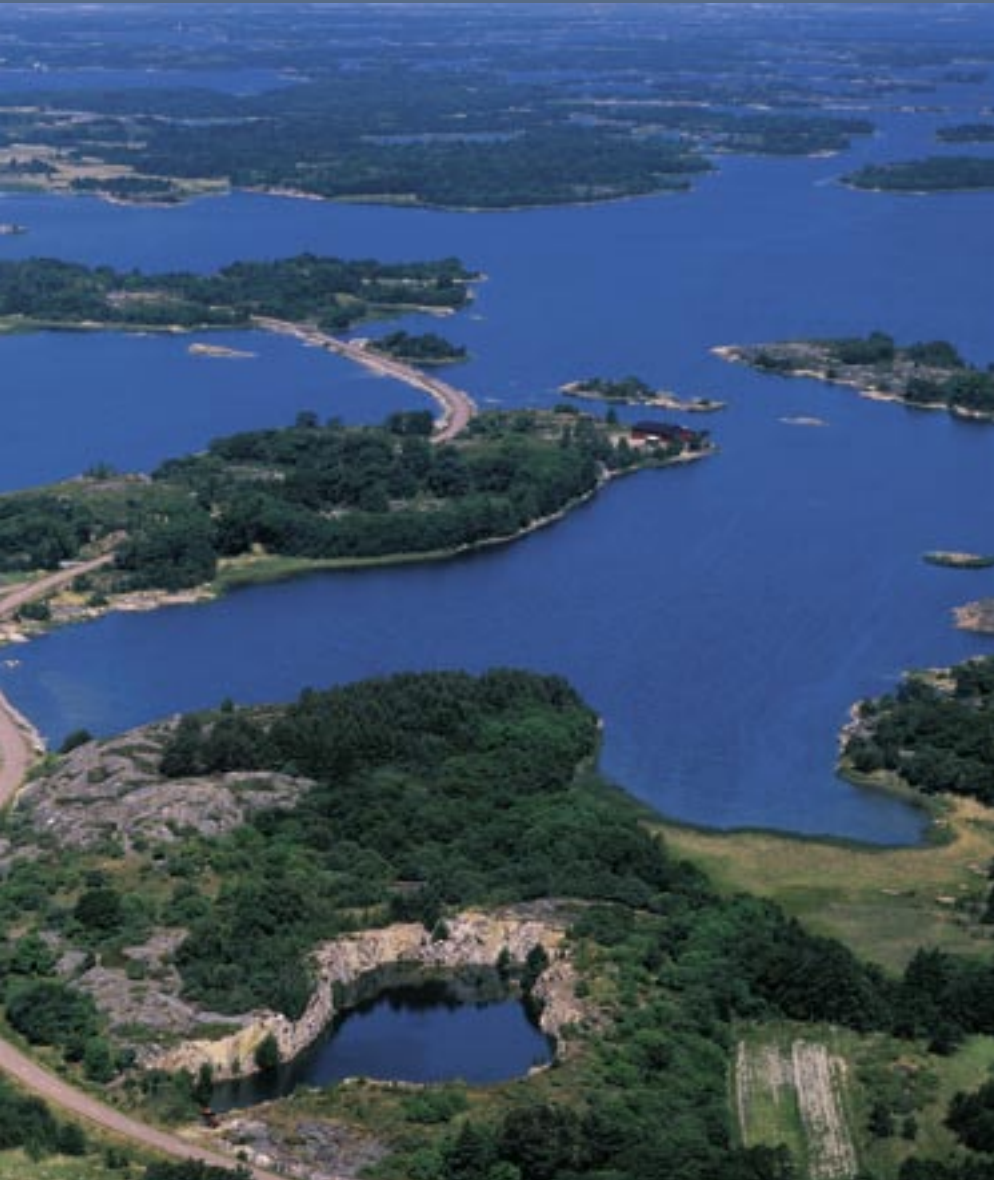
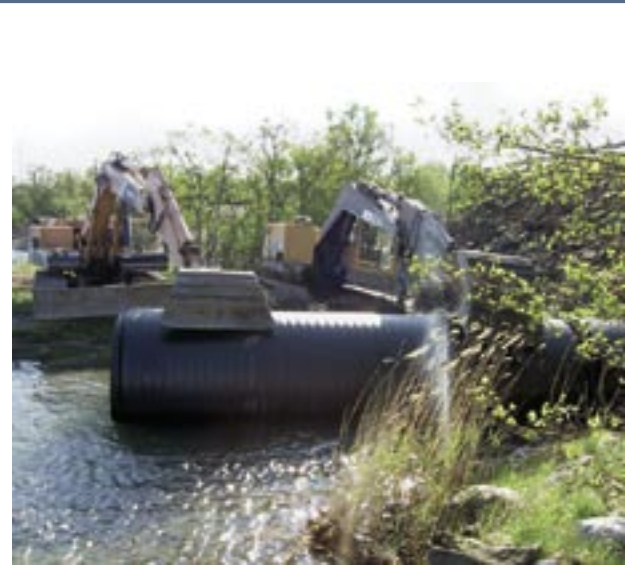
According to Mattsson, the sections were brought to the site by lorry and hoisted to the installation point using an excavator. The work was carried out under water by pushing the pipe through the sheet metal culvert. “The sea had to be calm for the duration of the work, so a day with very little wind was chosen.”

The installation work was over in about eight hours and involved two machines, a diver and two fitters. The traffic on the road was not affected.

“The diver went through the old culvert

using fire-fighting equipment to remove all sand, rocks and other litter from inside the pipe,” says Mattsson. “The next stage was the most difficult phase of the work as it involved bringing the first new pipe section to the mouth of the culvert. Sinking a large pipe under water was not easy, as it had considerable buoyancy, but in the end the fitters managed to push the pipe inside the culvert using iron bars. This is the kind of work where new solutions are needed every time.”

The remaining pipe sections did not pose any problems. As the new pipe has a smooth surface and is smaller than the old one, pushing it through the existing culvert was easy. One excavator was used to lift the sections, while the other helped

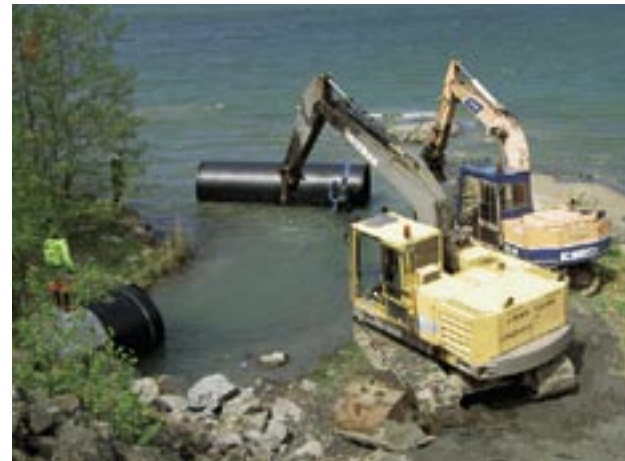
## THE PIPES

○ Weholite DN/ID 1,600 mm SN4,  
total length 30 metres.
