#### **MASSIVE CORROSION**

# Fault-free operations

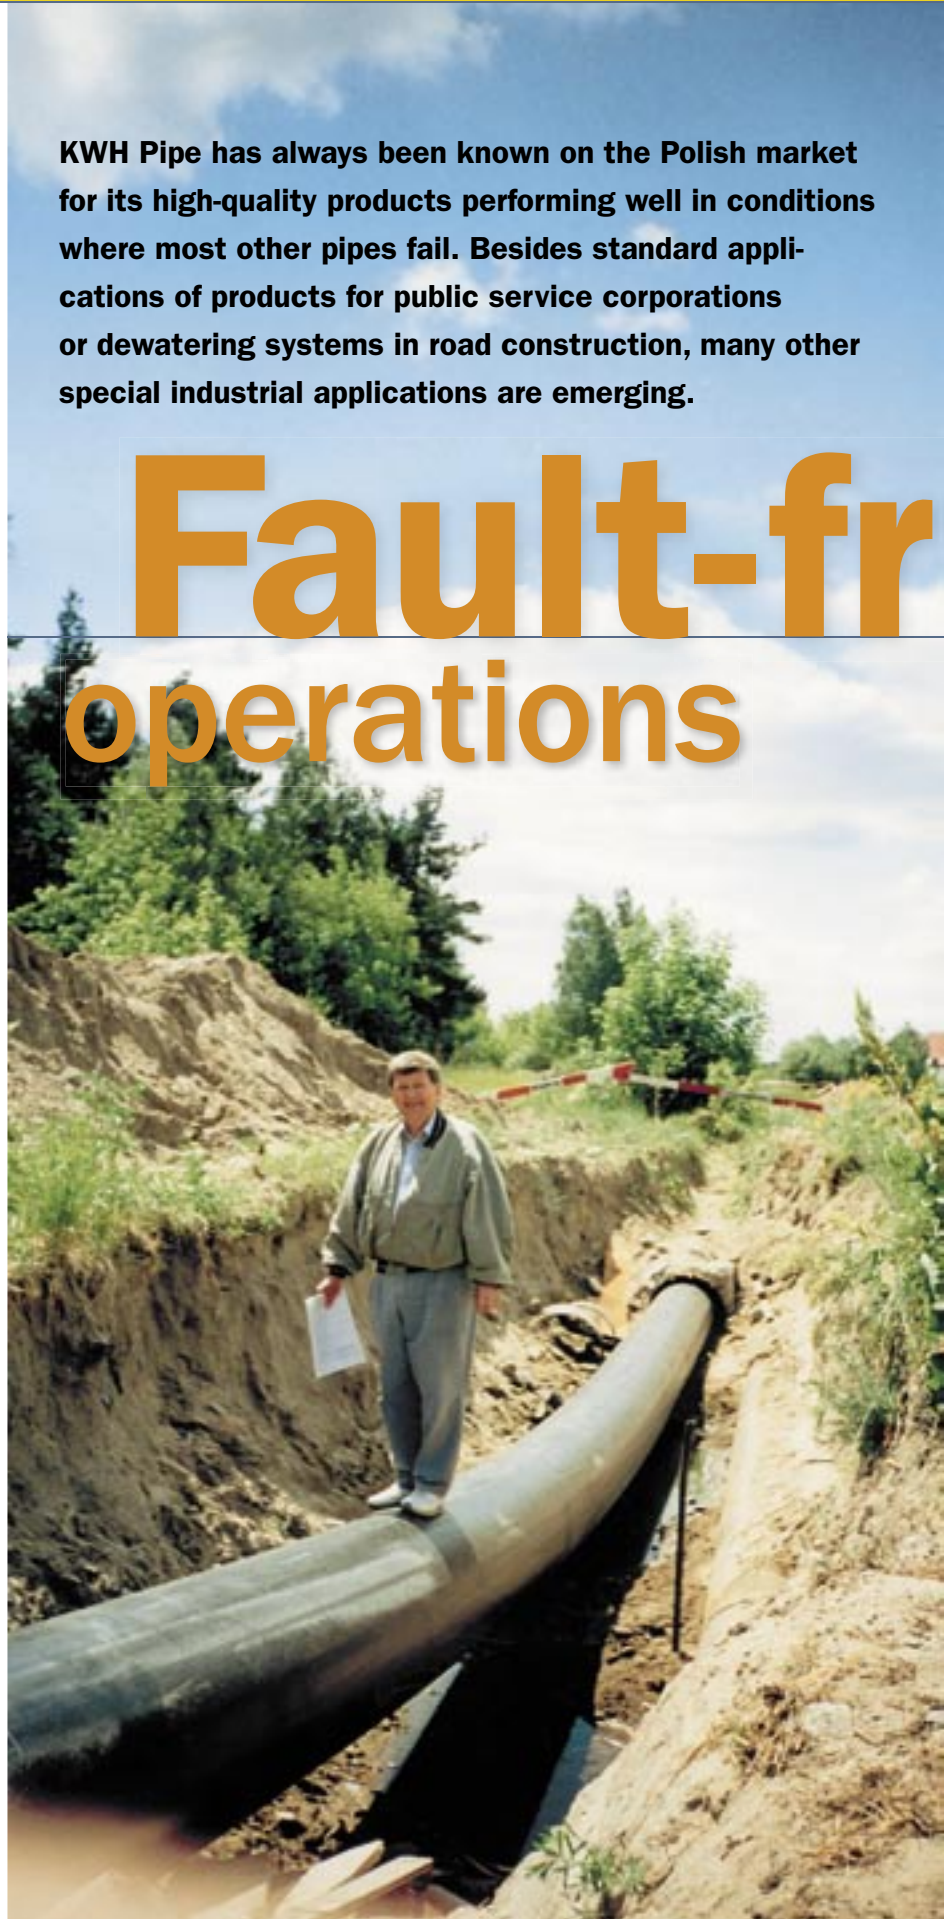
The pipeline used for transporting process liquid wastes from Zakłady Celulozowe to the biological treatment plant runs under the streets of the town of Ostrołęka. This pipeline has been in use since 1965. A 10 mm steel pipeline of nominal diameter 700 mm was used for transporting liquid wastes. Due to their aggressive nature, massive corrosion was detected after only a few years of operation. Part of the pipeline was repaired by constructing a reinforced concrete covering. This work required excavation along the entire length of the section undergoing repair. In spite of the covering, further corrosion of the pipeline occurred. Several failures and local leaks into the ground were experienced.

The removal of the reinforced concrete covering inside the excavations (B-30 concrete–20 cm thick) turned out to be the most time consuming task. The high degree of fouling and corrosion inside the pipeline was surprising. Concrete intrusions originating from the repair covering reduced the internal diameter of the pipe. Such intrusions (which are not a typical problem in repaired pressure pipelines) required vigorous mechanical cleaning. Pipeline sizing by pulling a PE pipe pilot section immediately behind the head to assess the degree of scratching on the pulled-in pipe is very important in such cases. The whole operation of pulling in the individual sections lasted less than twelve hours.

After receiving expert opinions in 1996, the investor decided to repair the most endangered section of the collecting pipe by relining it with long PE pipes. KWH Pipe offered complete delivery of the material together with execution as a turnkey project.

Taking temporary increases in the waste temperature of the transported liquid into account (in summer it can reach a maximum of 45°C under a forcing pressure at up to 0.35 Mpa), PN6 DN 630x37.3 mm PE63 pipe was selected. Eight installation cuts (starting and receiving) of approx. 15–18 m average length were used for inserting the pipes. The length of the inserted pipe sections varied from approx. 160 m to approx. 370 m. The work was completed inside 4 months.
