Ideal solutions for roads and railways

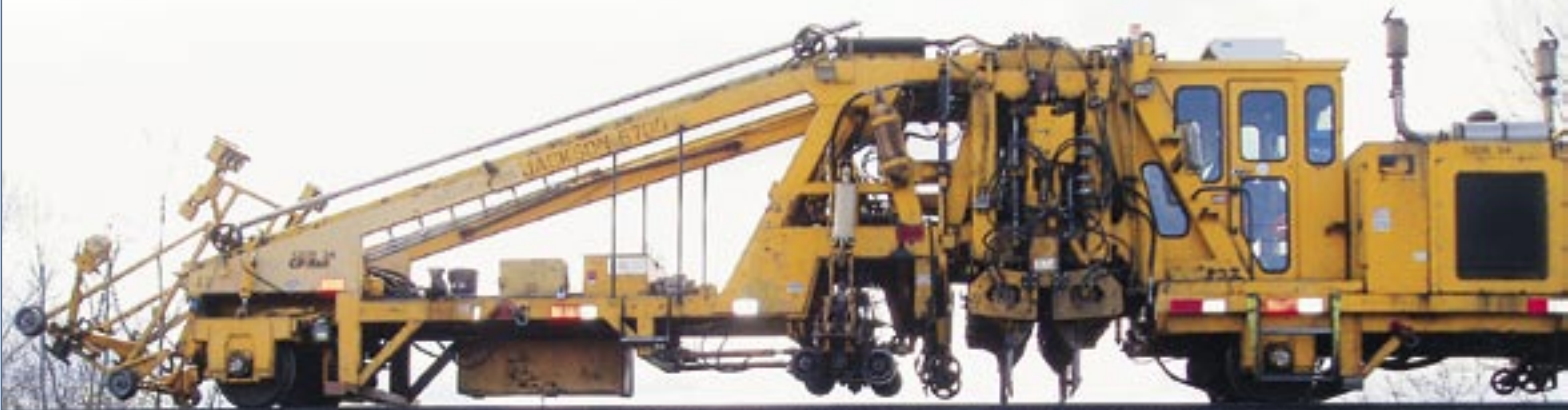
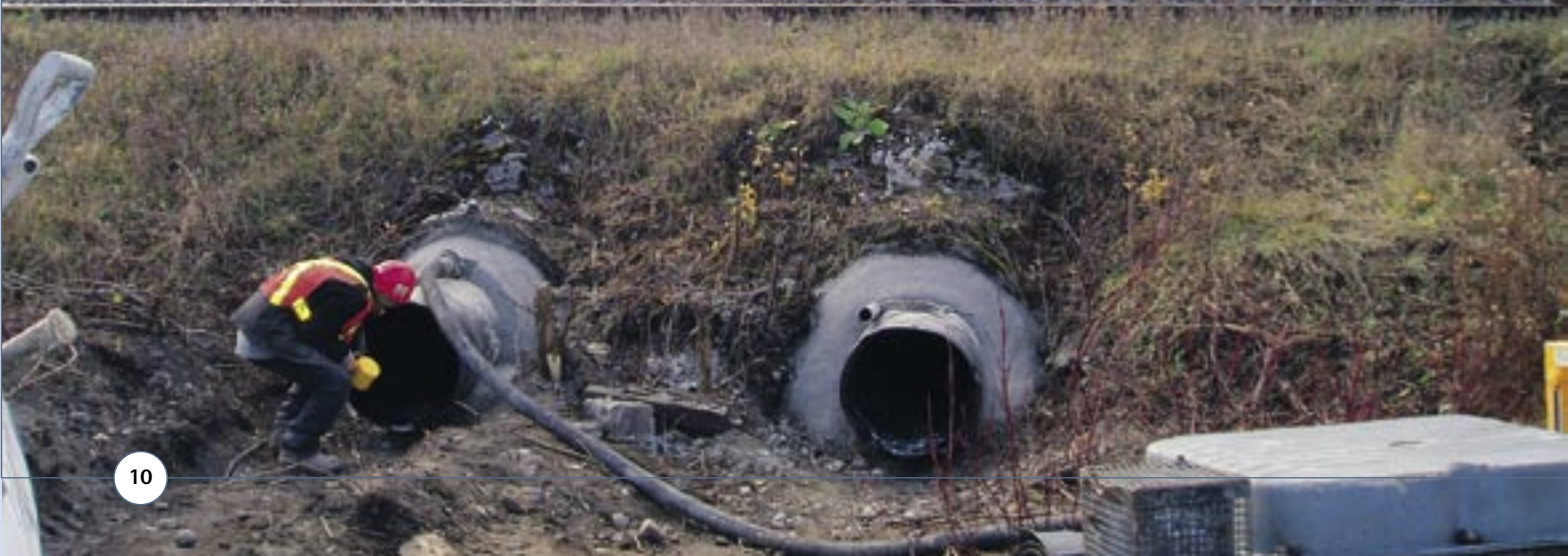
After a meeting between members of the Canadian National Railway (CN) project department and the consulting firm UMA, approval was given to renovate a concrete box culvert under the main CN railway

line, near l'Épiphanie, in Québec, Canada.

In making their final choice, the specialists at CN considered not only the quality of Weholite products, but the fact that the installation of threaded Weholite, which creates a product with a smooth interior and exterior wall, could be performed safely without interruptions to the train timetable.

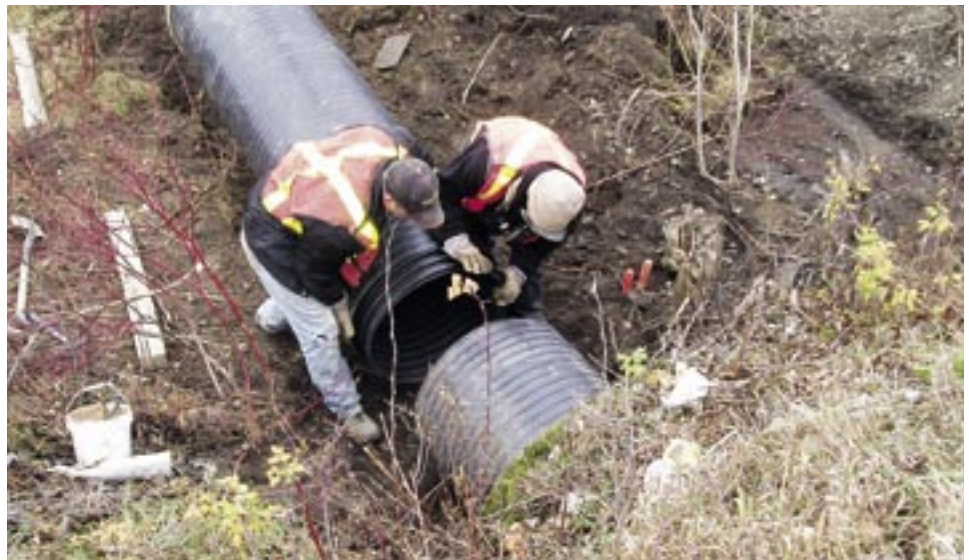
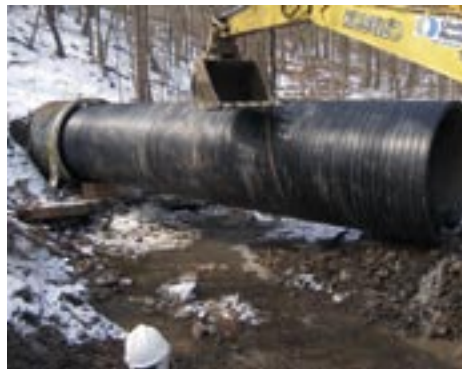
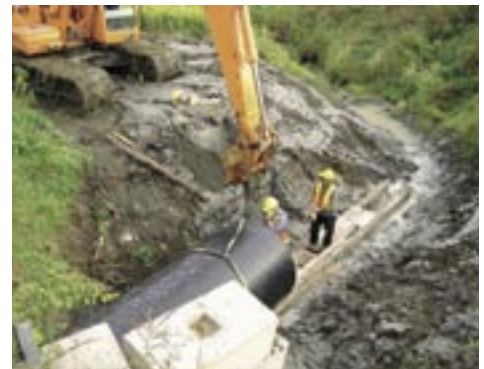
The culvert was sliplined with DN/ID 96 inch (approximately 2.4 m) Weholite. With a small work force of only four men, the team completed the project in record time.

The culvert was sliplined with DN/ID 96 inch (approximately 2.4 m) Weholite. Weholite was selected for its ease of installation, abrasion resistance and lon-
